# Manhole Inspection Summary

Manhole # S27E\_\_043MH

**Location** Address: **739 SARATOGA ST**

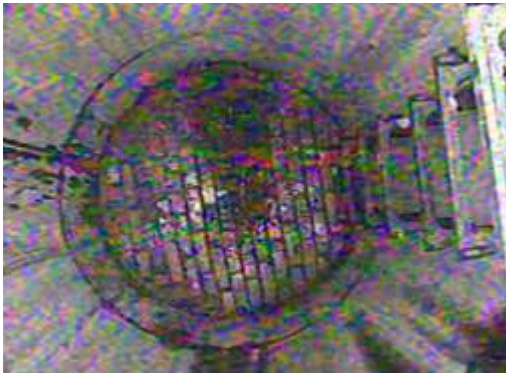
Top View

Condition: **Sound**

Condition: ☒ Sound ☐ Cracked ☐ Leaks

Condition: ☒ Sound ☐ Cracked ☐ Root Intrusion ☐ Loose Brick ☐ Deteriorated

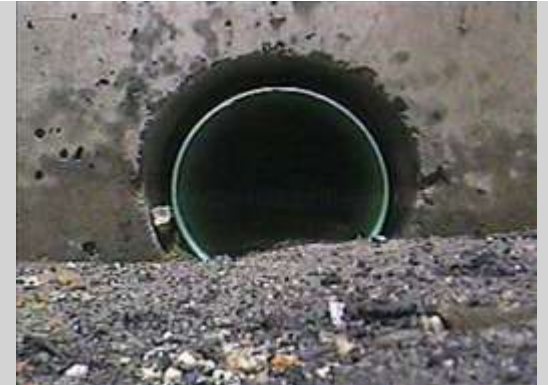
12 O'Clock Outflow

8 in. Circular Gravity Sewer  
Pipe Out @ 12 O'Clock

Deposits: ☒ None ☐ Mud ☐ Sludge ☐ Debris ☐ Grease

Infiltration: **None** Pipe Seal Cond: **Sound**
